Special Protection Area Program Annual Report 2005

Prepared by the Montgomery County Department of Environmental Protection in Cooperation With the Department of Permitting Services and the Maryland-National Capital Park and Planning Commission

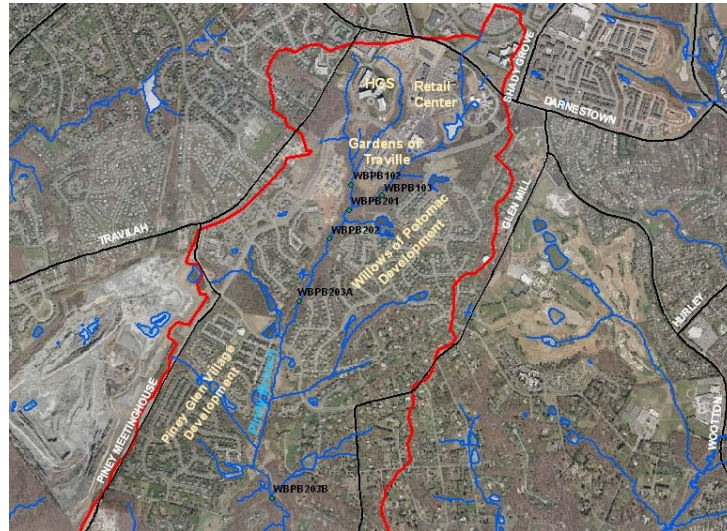
Figure 9. The 1998 Aerial photo of upper Piney Branch SPA - SPA boundary is delineated in red and stream monitoring locations are identified. Development of the Willows of Potomac, Piney Glen Village and Shady Grove Road can be seen.

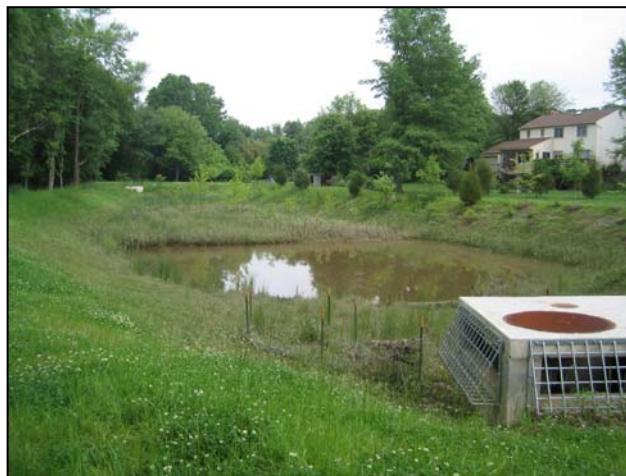
Figure 18. Piping Rock Road Stormwater Management Pond (photo taken in 2004)

DEP has completed three restoration projects, such as the Piping Rock Road stormwater management pond (Figure 18), in the upper portion of Good Hope watershed, which provide stormwater control for 209 acres of older development where none had previously existed. These projects have been shown to reduce peak storm flow in Good Hope by 78 percent on average (SPA Annual Report 2004).

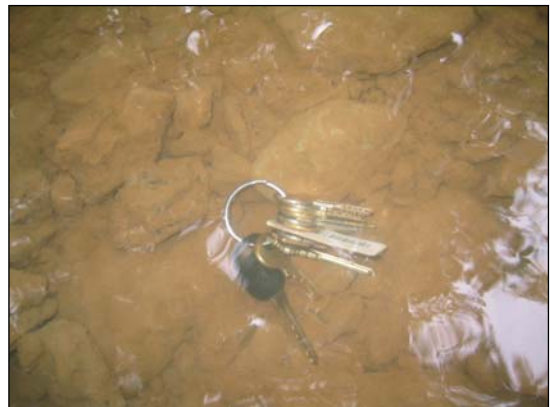
Figure 22. Stream Bottom at Station LSLS103C
